Manhole Inspection Summary

Manhole # S53C__061MH

Insp Date: **6/12/08 12:33 PM**

Location Address: **3200 e fairmount ave**

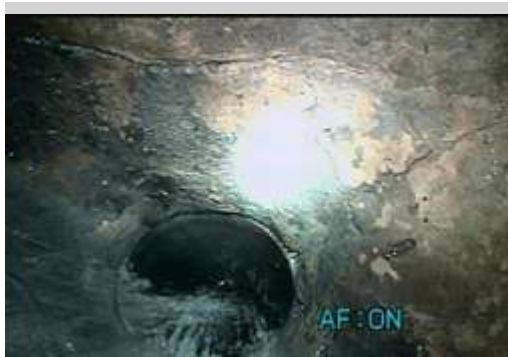
Miscellaneous

inside shelf opening for 6 OClock Drop In

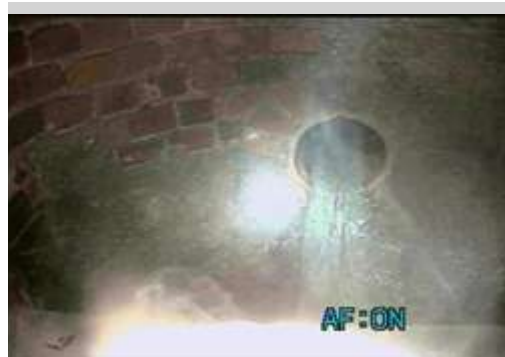
Misc

Pipe In @ 6 OClock is in a shelf in the upper portion of the MH.

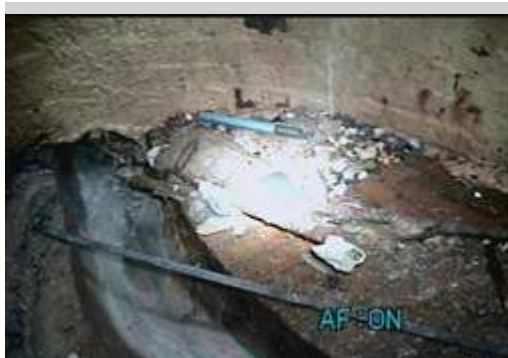
Miscellaneous

bench debris

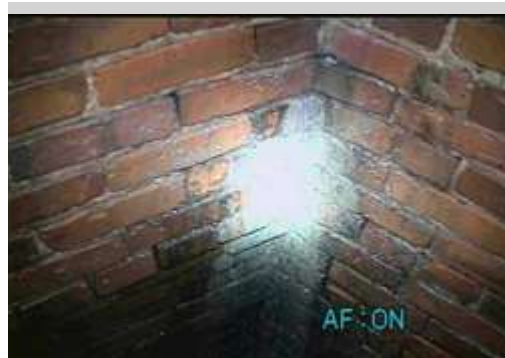
Defect 5

Comments **Has alot of infiltration in barrel & corbel also there is no pipe at 9.**

Condition: ☐ Sound ☒ **Cracked** ☐ Root Intrusion ☐ Loose Brick ☐ Deteriorated

Infiltration: ☐ None ☒ **Joint** ☐ Cracks ☐ Mortar ☐ Roots ☒ **Wall**

corbel infiltration at chimney joint and wall

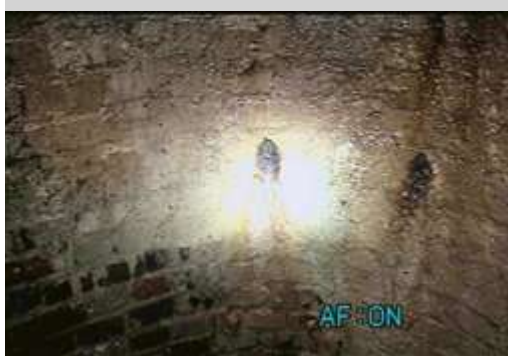
Defect 4

Infiltration: ☐ None ☐ Joint ☒ **Cracks** ☐ Mortar ☐ Roots ☒ **Wall**

barrel infiltration at wall

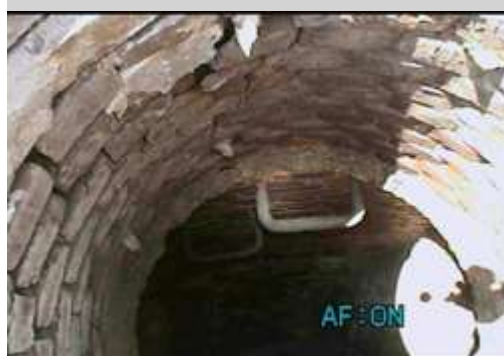
Defect 3

Steps Count: **8** Missing: **2** ☒ **Corroded**

steps corroded and missing

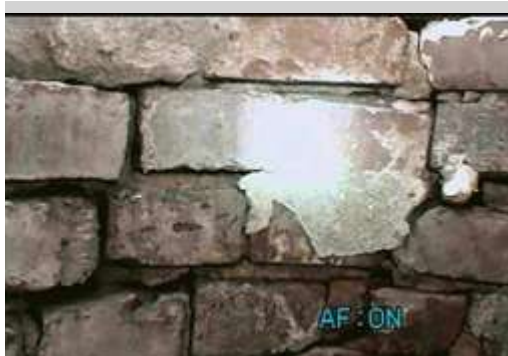
Defect 2

corbel cracked

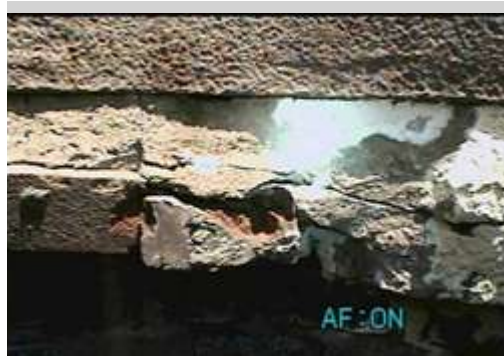
Defect 1

Condition: ☐ Sound ☒ **Cracked** ☐ Root Intrusion ☐ Loose Brick ☐ Deteriorated

chimney cracked at frame joint

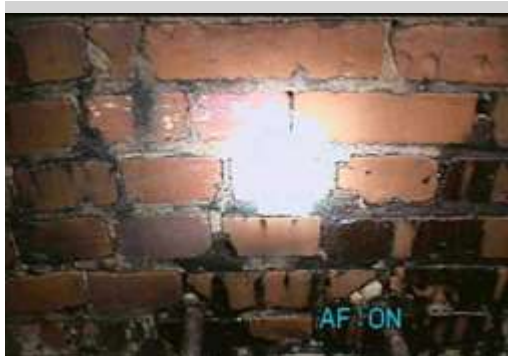
Defect 6

barrel infiltration at cracks

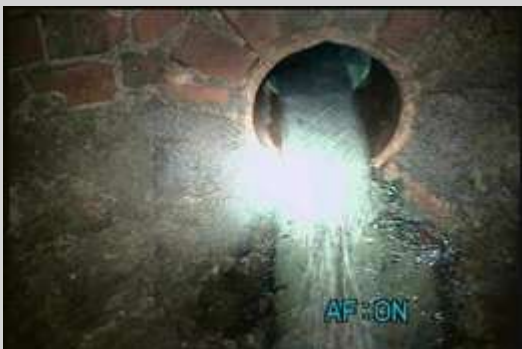
6 O'Clock Inflow

clay pipe, then pvc pipe outside MH
